## FORD:

2004-2007 F-Super Duty

## TSB 06-15-5 (Continued)

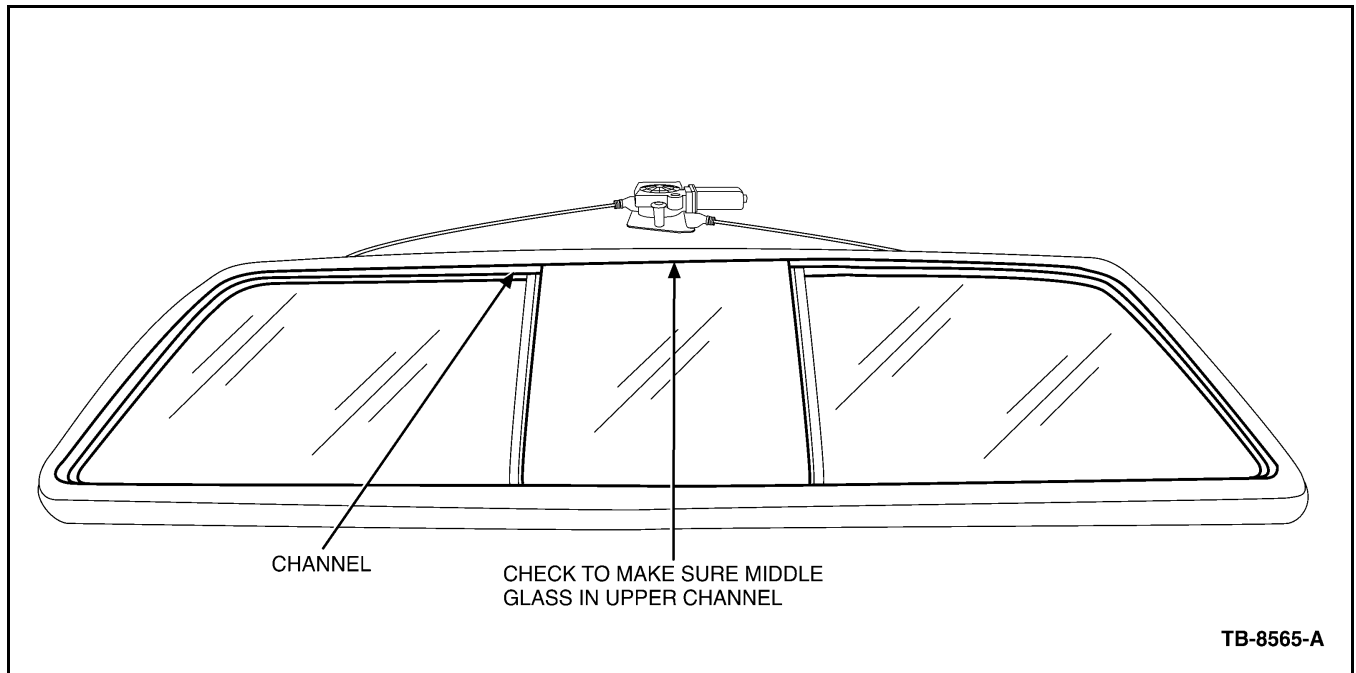
Figure 1 - Article 06-15-5

Some 2004-2007 F-Super Duty vehicles, equipped with a power sliding rear window (back glass), may exhibit a stuck or binding concern. This condition may be due to the center glass not being positioned correctly inside the upper or lower channel, the channel being warped, bent, or center glass de-bonded.

1. Prior to window removal, verify that center glass is centered in the upper plastic channel (Figure 1). If center glass is not inside upper plastic channel, pull channel down and out of upper aluminum channel and slide back in making sure the entire center glass is inside the plastic channel.
