Melling LPOP Install By Duck Fan and Stewart_H

Posted on FTE 08-22-2010

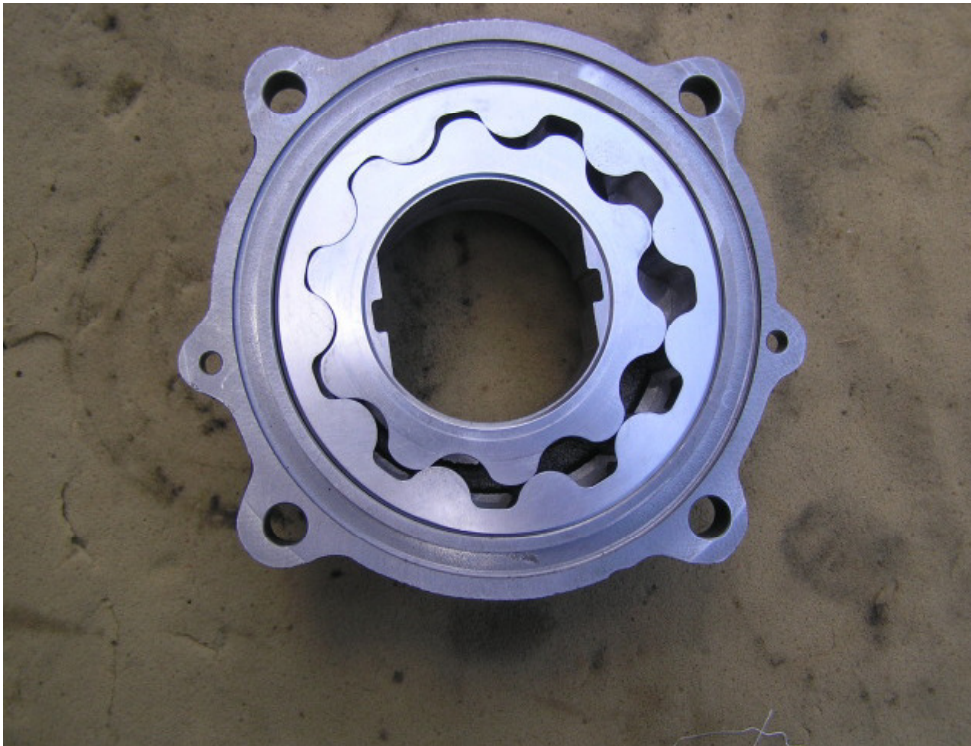
I went to my local Autozone and ordered Melling M208. It was about \$75 ish plus tax. Had it in 2 days.

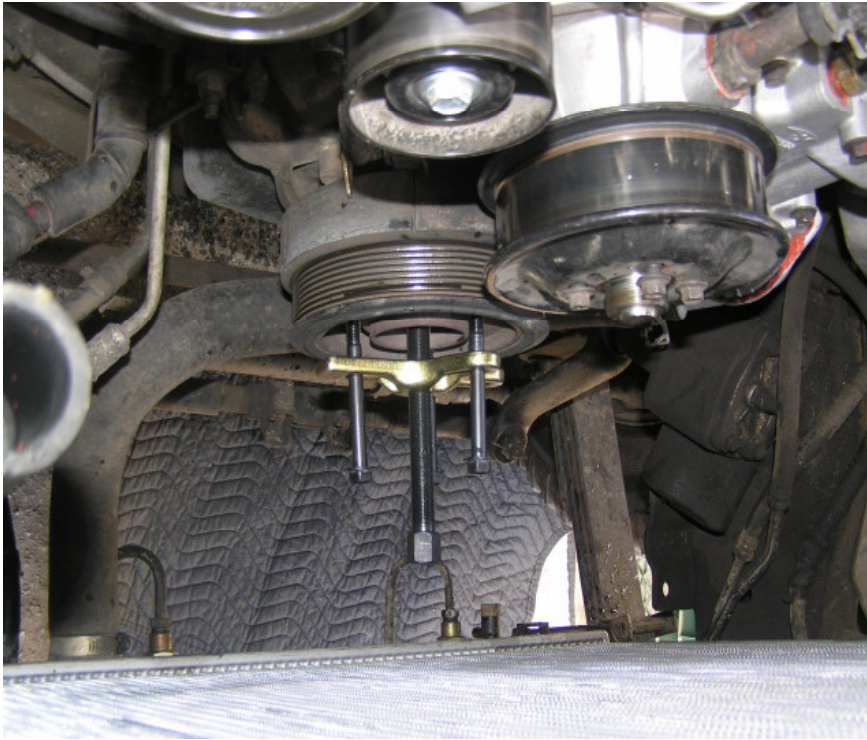
From there, rent a harmonic balancer puller and thread the 3 bolts in:

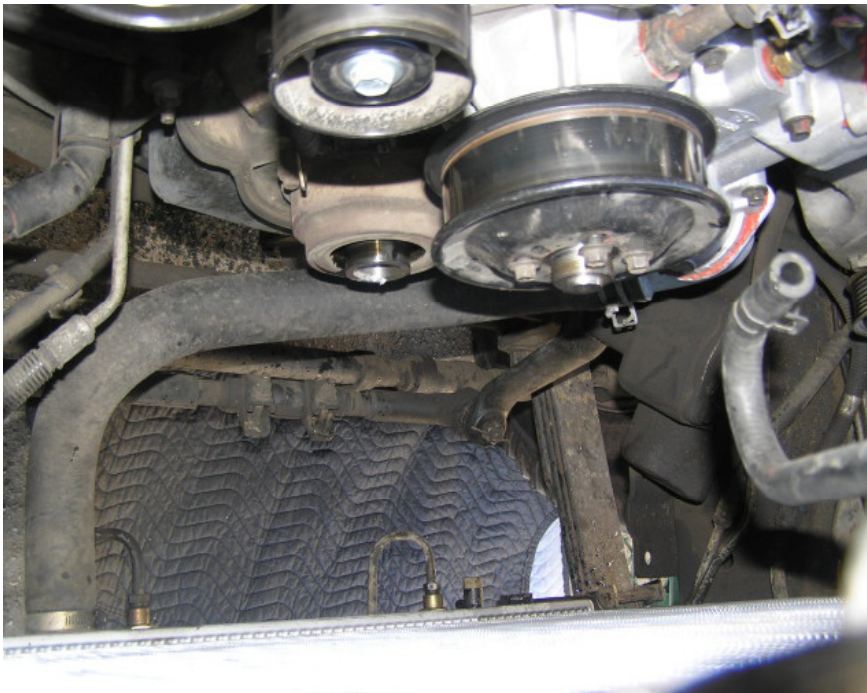
Crank on that big bolt in the center and:

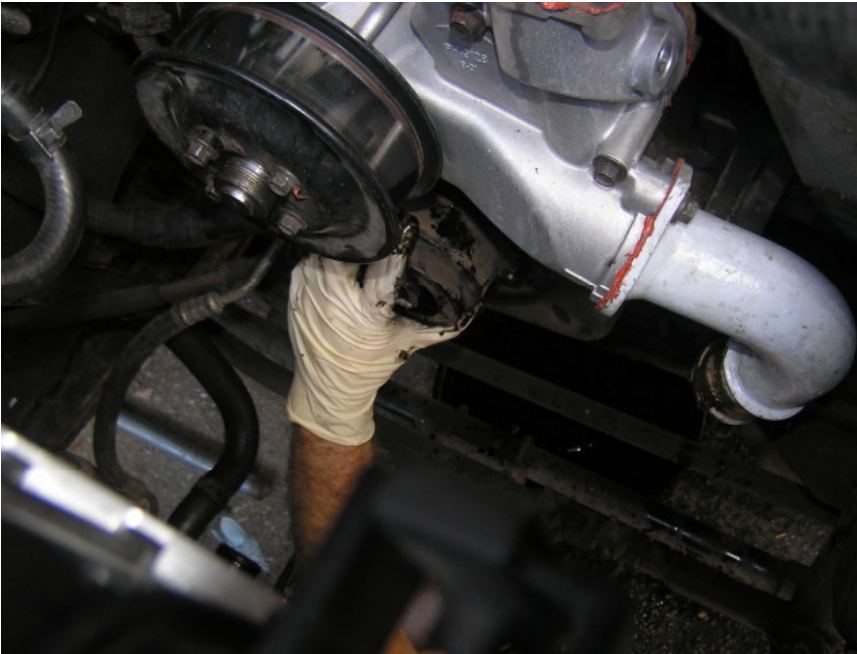
The LPOP is held in by 4 10mm bolts. Remove those and scratch your head on how to remove the pump body from the block.

We did not get pics of what worked but if you look at the above picture, there is a gap between the pump body and the snout of the crank, there is a lip in there you can pry on (gently) or use a 3 jaw puller turned inside out.

Using a flat head screwdriver, we both gently pried around the lip Pete referred to and after

a few different pry's from different angles, we got the body popped off. It actually came off fairly easy, even though we were being overly cautious so as not to bend, gouge, or screw anything up.

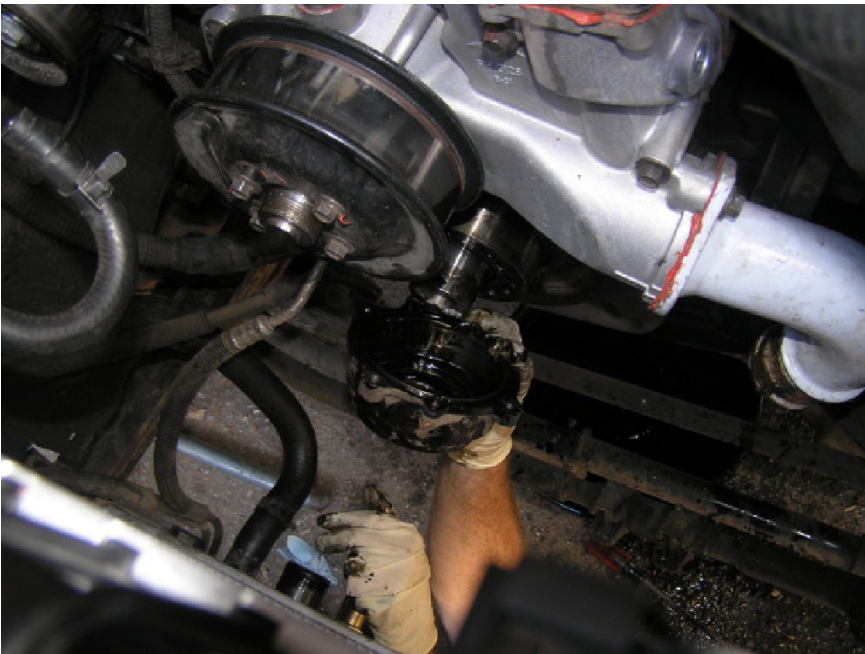
Once the body is off,

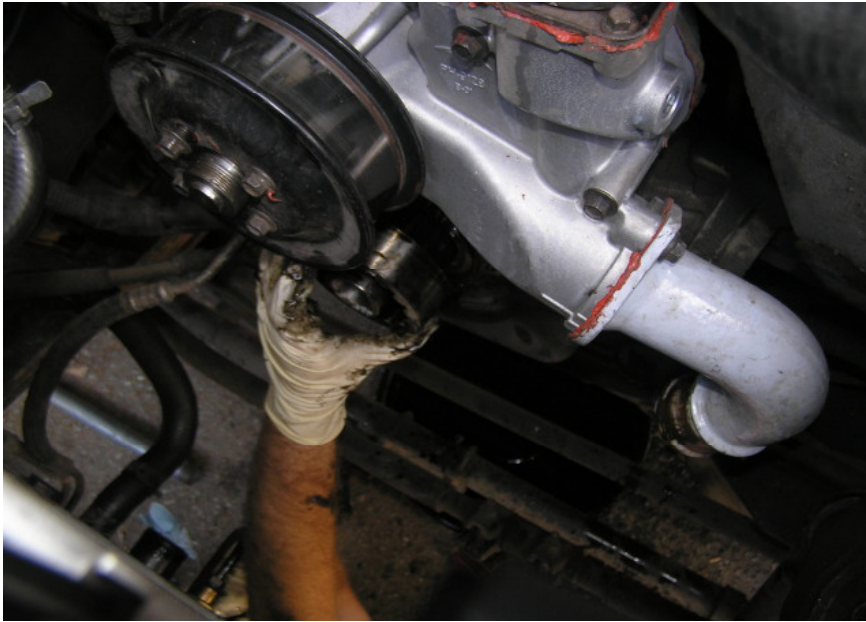
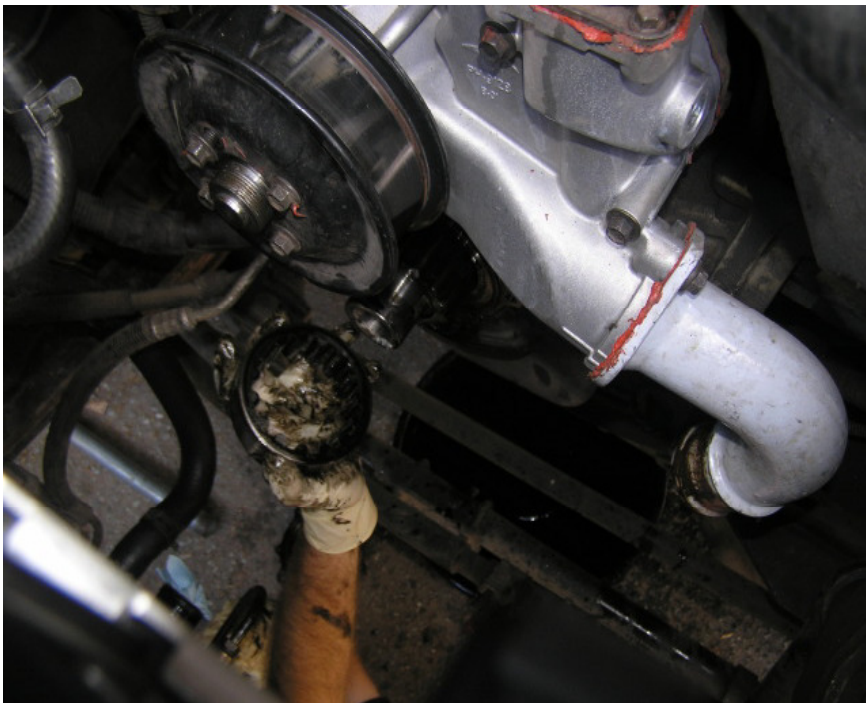
remove the outer pump rotor:

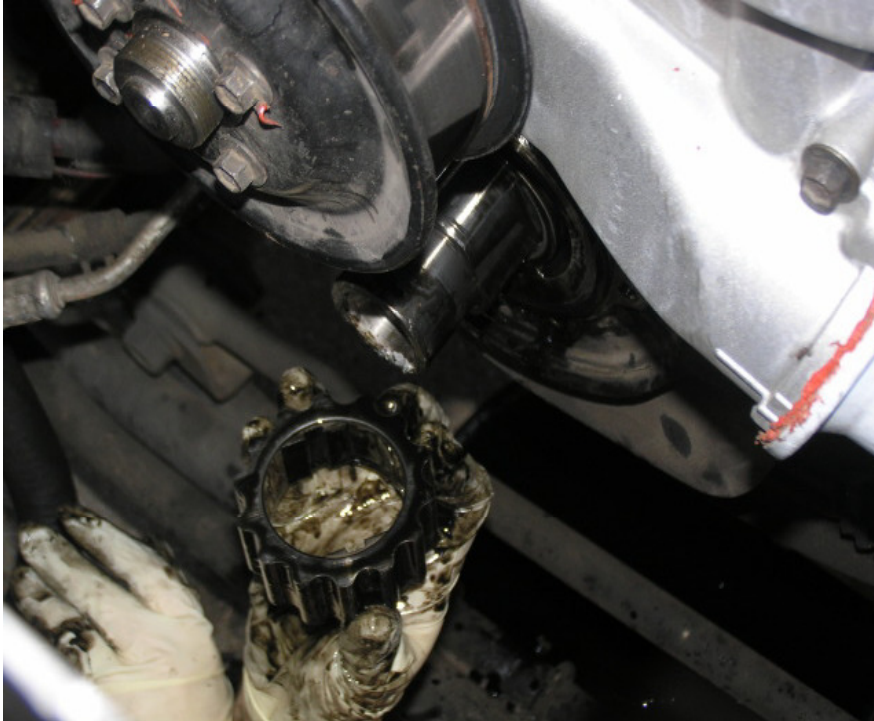
Then the inner rotor:

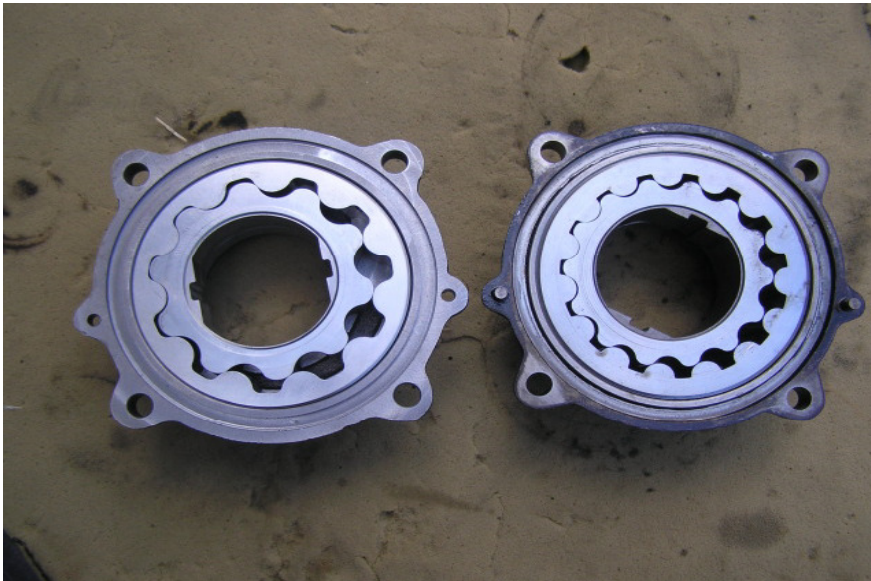
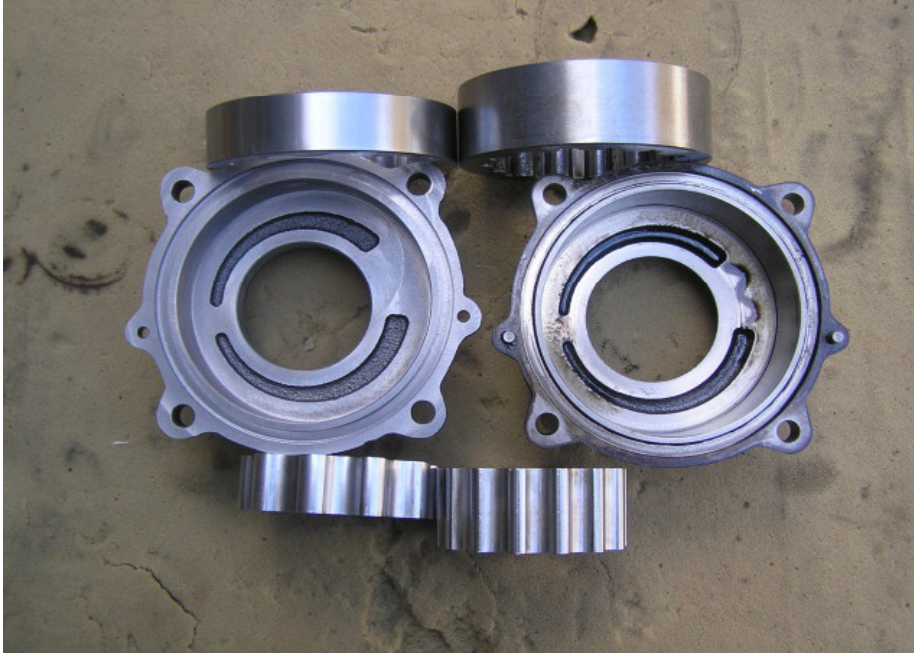
Now, the Melling M208 has less "teeth" on its rotors as opposed to the OEM pump. According to Melling, this allows for greater volume at equal psi. Also, the Melling is narrower than the OEM pump. Notice the difference in clearance from the old to the new. It was worn out:

For once, installation is literally the reverse of removal. A couple of notes, the instructions tell you to place the body of the new pump on the dowel pins on the block. Well, those came out with the old pump and had to be tapped out and moved over.

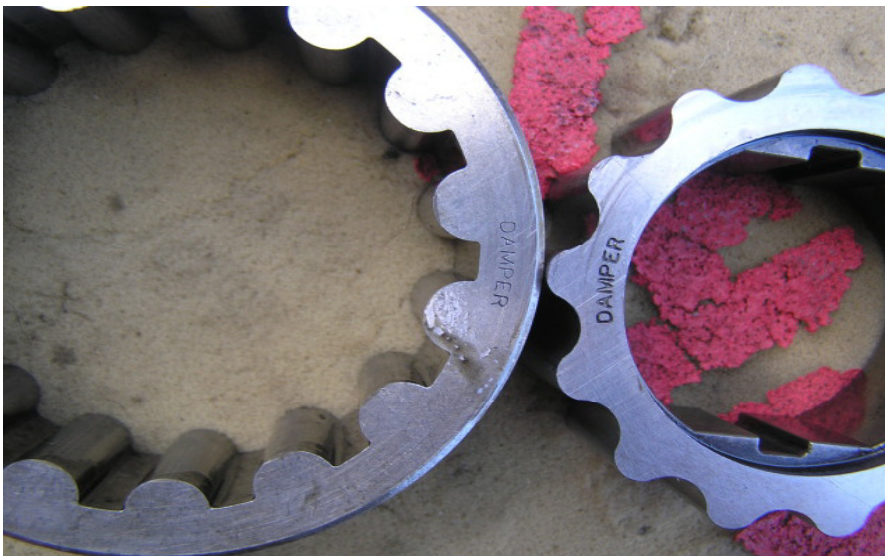
Secondly, should you chose to use a new OEM pump, the rotors are stamped "damper" on one side:

and must only be installed with that side towards the harmonic balancer. Otherwise, save your money for a new front cover. The Melling on the other hand, is universal and may be installed either way.

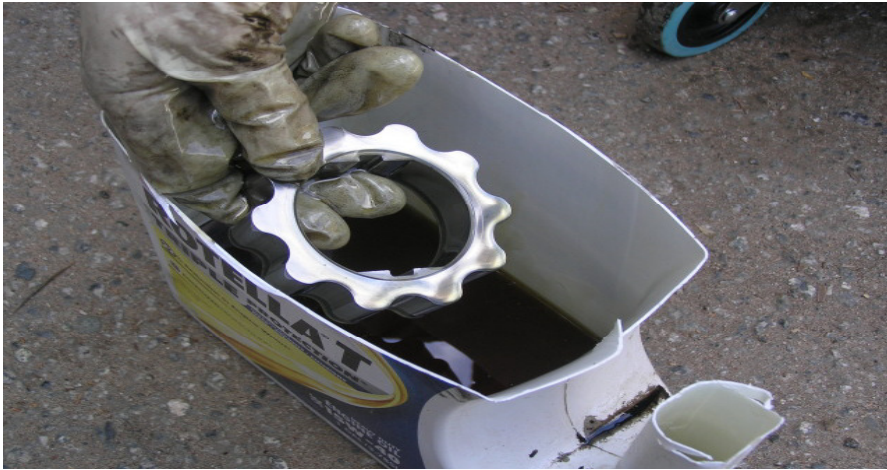
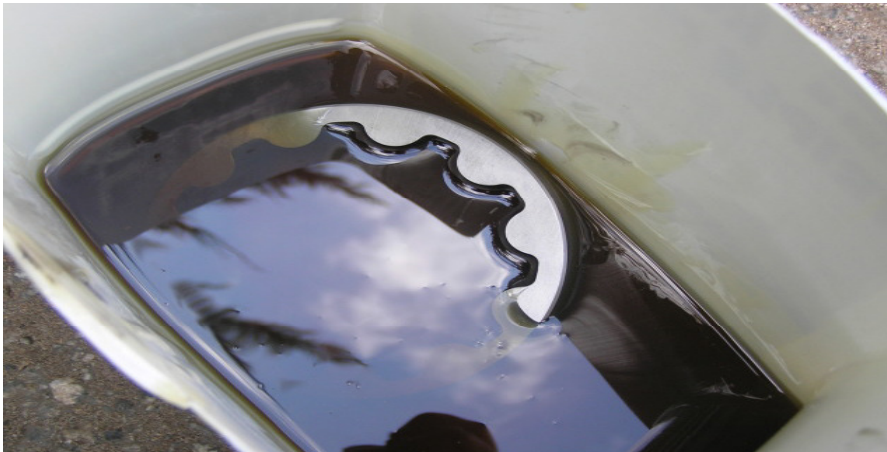
Be sure to coat both rotors liberally with oil prior to install.
