Authorized Field Change

AFC 08904

Subject: VT 275 and MaxxForce 5 Case to Head Tube and Plug D-Ring Seal Deterioration

Model: Workhorse Chassis : WAZ, W6Z
Start Date: 06/01/2004 End Date: 01/10/2008

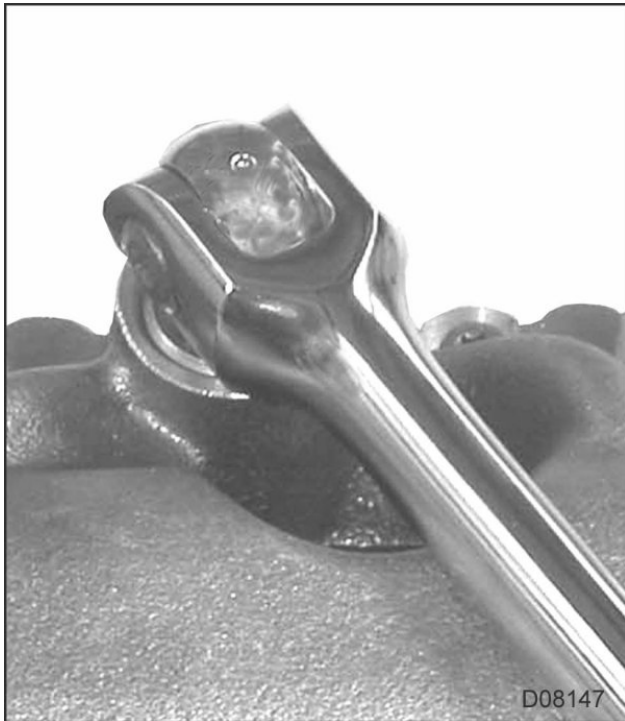
Figure 4 Removing Crankcase-to-Head Tube Plug (square head socket shown)

16. Remove case-to-head tube plug and the rail port plug with a 10 mm hex bit socket or wrench (Figure 4).

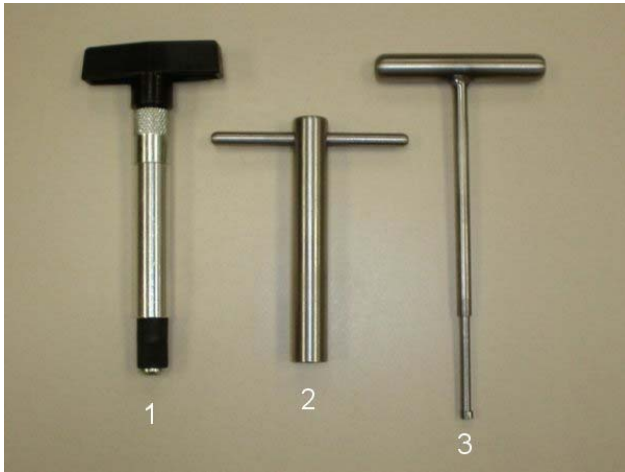
Figure 8 Crankcase-to-Head Tube Removal Tool

1. Tube Removal Tool ZTSE4694A
2. Lower Plug and Tube Removal Tool ZTSE4923
3. Broken Lower Plug Removal Tool ZTSE4922

18. Insert the Crankcase-to-head tube Removal Tool (Item 1, Figure 8) into the crankcase-to-head tube, tighten T-handle, and pull out tube. If the lower portion of the plug remains in the lower crankcase-to-head tube, use tool 2 to attach to the lower plug and pull out plug and tube.

If the lower portion of the plug has had the threaded top broken off, use tool 3 to hook the plug and pull out plug and tube.

New service tools were shipped the week of May 19, 2008 to accommodate the situation that might occur on the removal of the case-to-head tubes. These new tools are shown in Figure 8.
