## 2001 – 2007 6.6L Duramax Diagnostics

### High Pressure Common Rail Basic Information

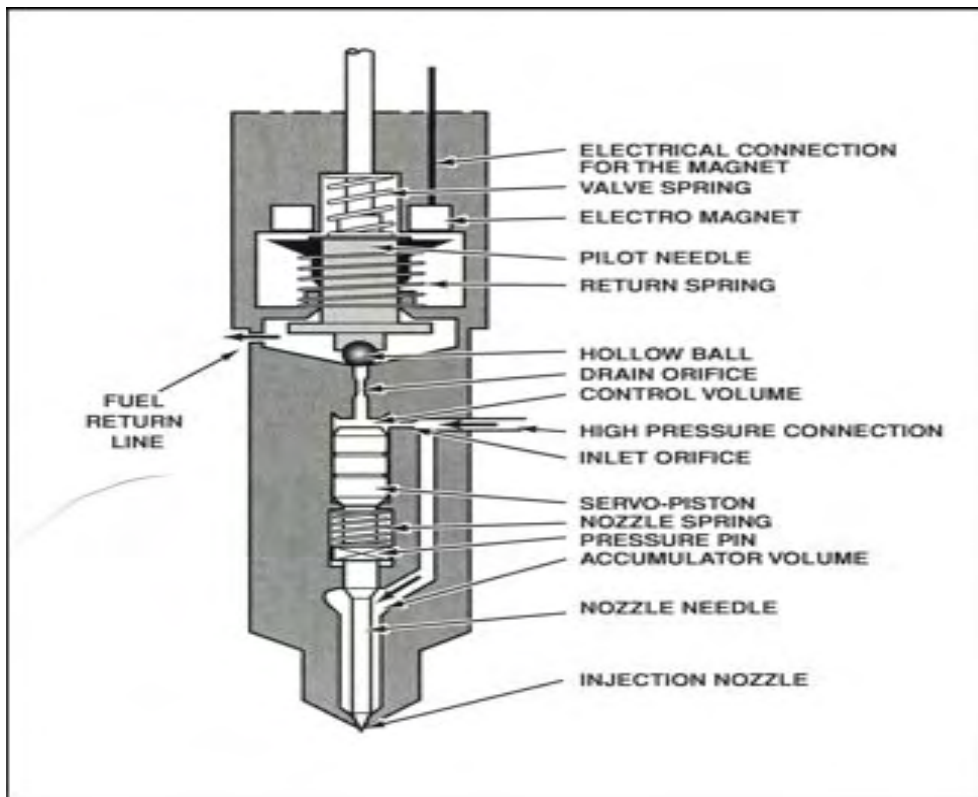
The high pressure pump builds rail pressure and delivers it to the fuel rail manifold where it flows through the injector lines to the injectors. The fuel pressure regulator in the high pressure pump controls rail pressure. The injectors have a hollow check ball that holds high pressure fuel until the fuel solenoid is actuated by the ECM, this allows the check ball to rise off its seat and an injection to take place. If the check ball in the injector is leaking due to erosion on the seat or the high pressure limit valve leaks then it will not build enough rail pressure to start the engine. It takes approximately 2500 PSI 2500 PSI rail pressure to start the engine.
