Photo Tech By Ron Henni Undercar Dig

By Ron Henningsen Undercar Digest Technical Editor

Performance Diesel Clutches

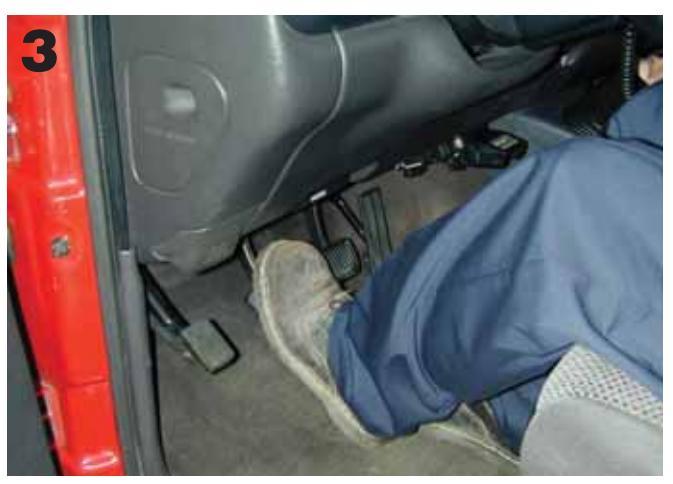
Clutch problems include slippage, insufficient free play and engagement difficulty. One of the primary checks of a clutch is for initial free play. If you don't know what is normal, however, you won't know what is abnormal.

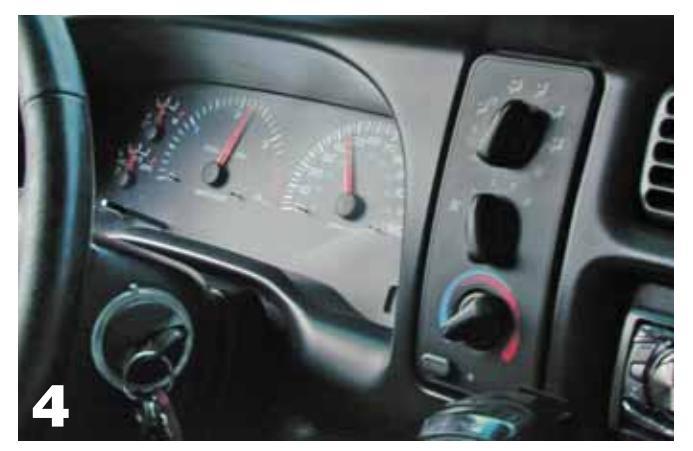
Another clutch check on a performance diesel vehicle involves driving at highway speeds and accelerating, or downshifting and accelerating. Watch the tachometer on the dash. Often, initial slippage of the clutch will show up as an engine-speed spike. You should always perform this check before doing any clutch work on a performance diesel.

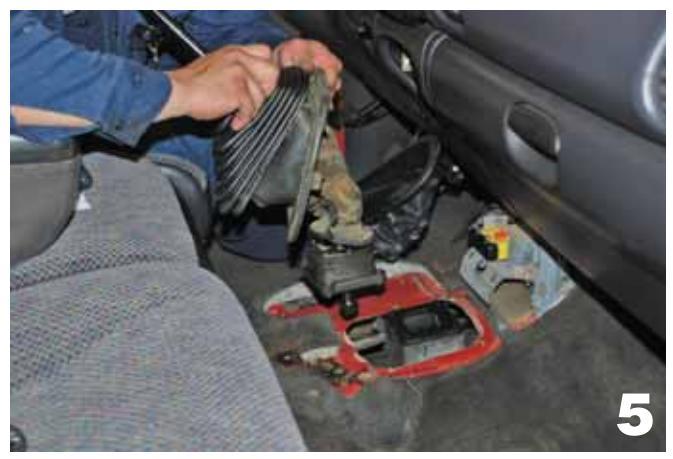
The first step in replacing a clutch on most diesel pickups is to remove the shift linkage from the transmission. This is easily done through the passenger compartment. Of course, you need to be careful to keep the vehicle's interior clean and keep track of all the bolts, clips, trim pieces etc.

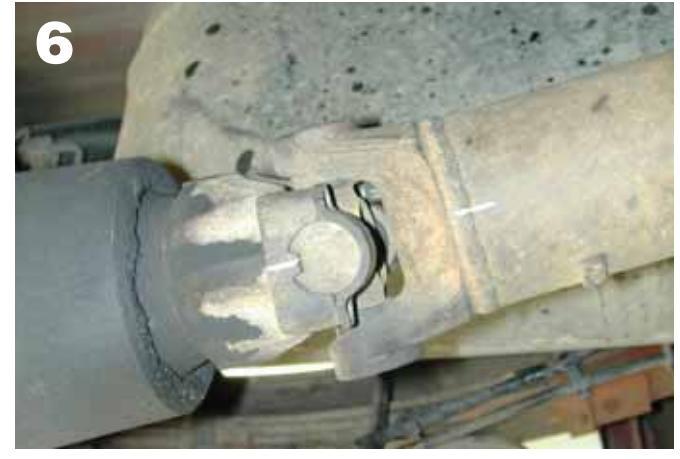
Marking or indexing the driveshaft in relation to the yoke on the differential is a procedure that has existed as long as universal joints have been used. Failure to do this can result in imbalance and vibration.

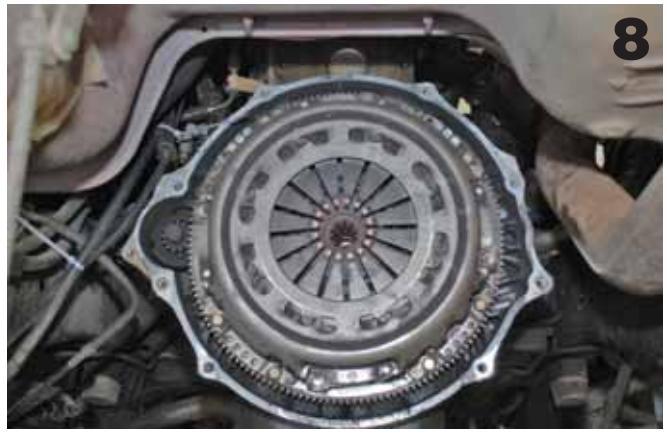
After removing the transmission, don't remove the pressure plate and clutch disc immediately. Do a quick visual inspection for obvious problems such as broken parts, scraping, binding or, in this case, a dowel pin missing from the bellhousing.

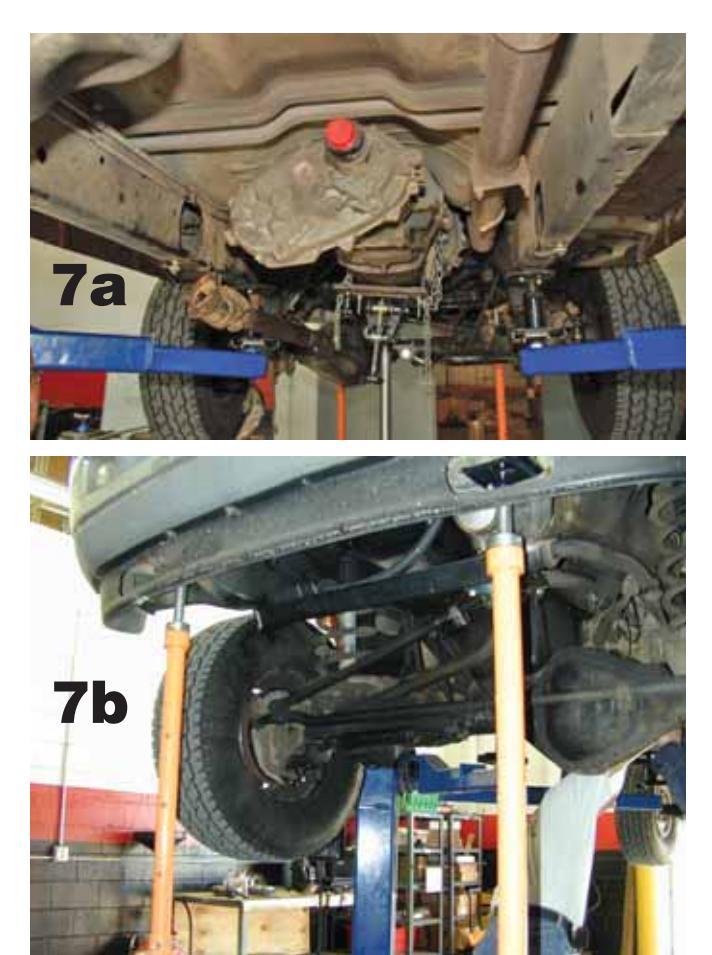
The transmission with the transfer case still attached is mounted securely on a transmission jack. Depending on your work habits, you may wish to remove the transfer case separately to reduce the overall weight, but many transmissions on diesel pickups can be lowered with the transfer case in place. The primary consideration is to support the transmission properly on a transmission jack. Also note the supports at the front of the vehicle. When you are removing the transmission from a diesel pickup it is best to securely support the vehicle, not just rely upon the lift pads.

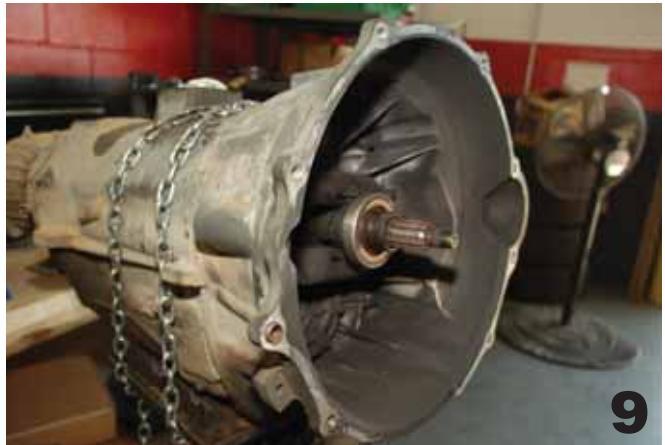
There is a dowel pin on only the right-hand side. Also notice the transmission input shaft in the area that would have been contacting the pilot bearing. Only the tip of the shaft has been contacting the pilot bearing. Failure to notice such items may lead you to replace the clutch without curing the real problems.

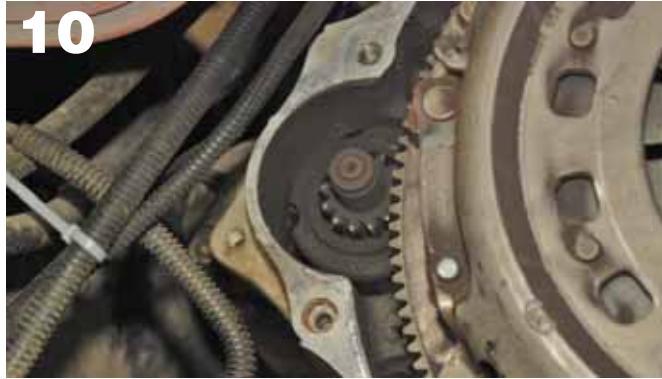
The area of the bellhousing where the dowel pin was missing had a buildup of rust and scale. Also note the starter-motor mounting position and its teeth. This is a good time to determine whether a different flywheel has been installed and whether clutch-in and starter-motor engagement is correct. Installation of certain aftermarket performance flywheels and clutch systems may require addition of spacers for the starter motor. Dodge has spacers available for some options, and they are included in premium aftermarket kits.

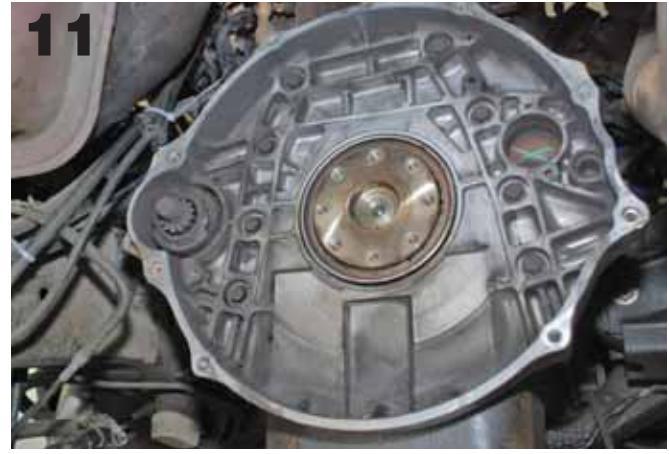
With the clutch assembly and flywheel removed, a quick visual inspection shows everything to be in good order except for the missing dowel pin. There are no cracks, nicks, breaks, pry marks, areas of contact with rotating components etc., so at this time the clutch reinstallation can begin.

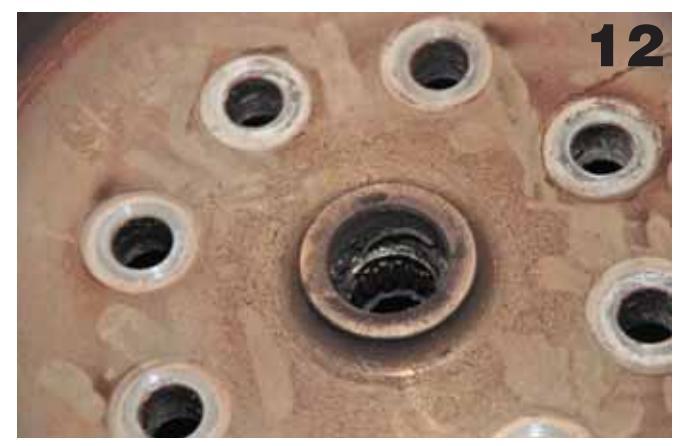
One key to how well a new clutch will work is determining what was wrong with the old one. Note that the pilot bearing has been pressed too far into the flywheel. The bearing should be flush. This is why just the end of the transmission input shaft was contacting the pilot bearing. Along with the missing dowel pin, this easily could have led to a misaligned clutch disc and possible engagement slippage or other problems.

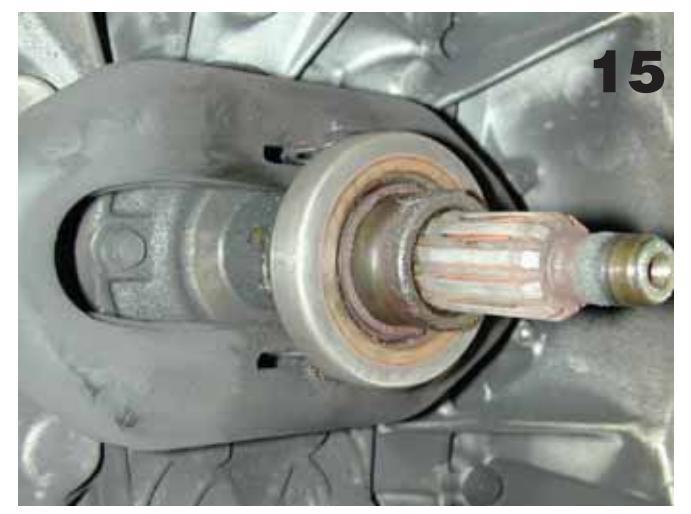
The release bearing slides on the transmission input shaft. Note the small metal shavings and particles on the part of the input shaft that contacted the pilot bearing.

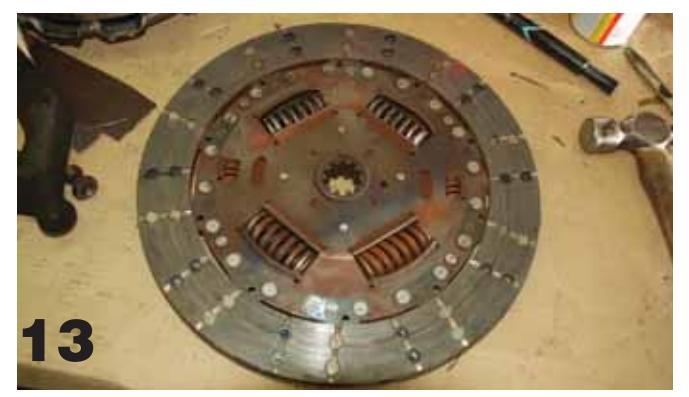
Note the rust or red dust around the damping springs on the clutch disc that was removed. There are no cracks in the disc, but the damping spring openings at the 11 and 1 o'clock positions appear larger and the springs are not being properly retained. This is one sign of a clutch that is starting to fail. On a performance clutch that is engineered to handle the torque, this will not be an issue.

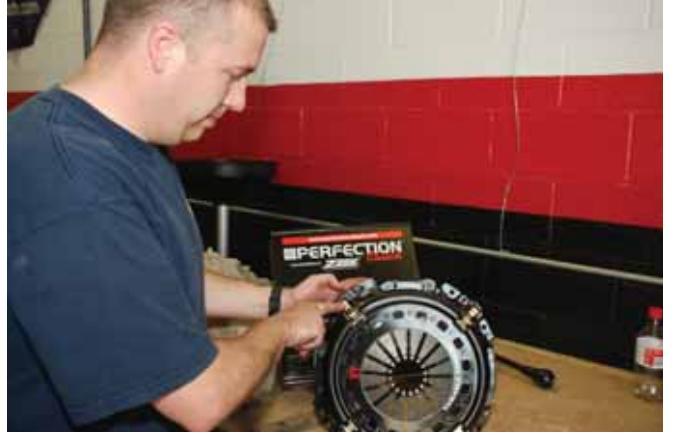
The owner of the pickup examines the clutch assembly's variable-torque feature. As this clutch rotates faster, centrifugal force increases the clamping force. This allows high-performance diesels with higher engine speeds and shift points to maintain the proper clamping load at the right time for smooth shifts with no slipping.
